# RMS TITANIC:

THE ACCIDENT, THE INVESTIGATION & COMPARING TO EHS STANDARDS OF TODAY

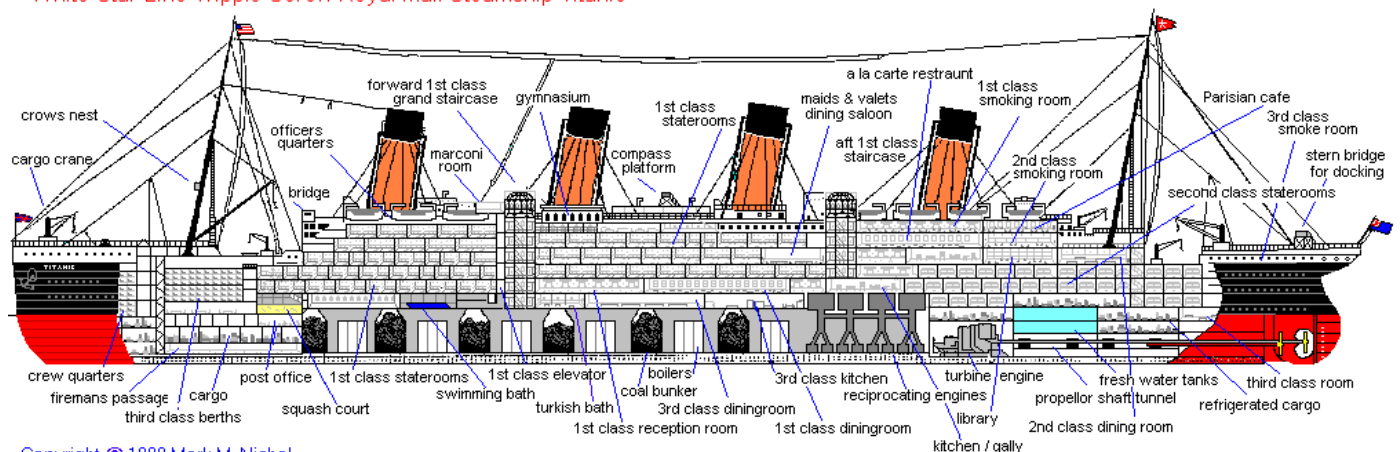
White Star Line Tripple Screw Royal Mail Steamship Titanic

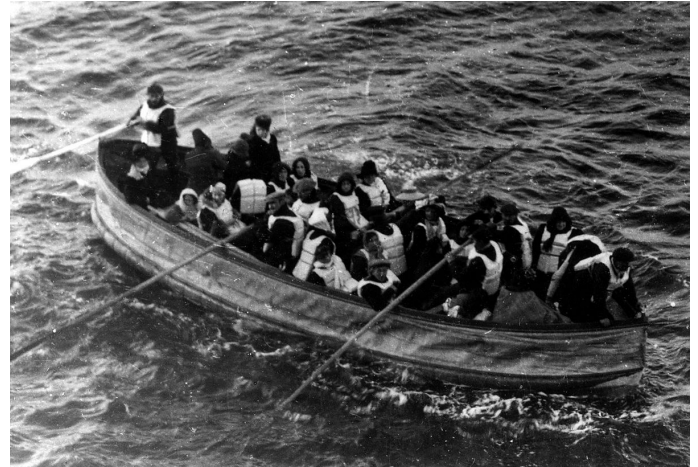
**Image 12: Partially flooded with ice-cold seawater, Titanic's Collapsible Boat D approaches RMS Carpathia at 7:15 am. on 15 April 1912.**
